**Re: Ameren Missouri
Labadie Power Station
Response to O'Brien & Gere Draft Dam Safety Assessment of
CCW Impoundments**

This report presents our findings and recommendations from the geotechnical field investigations, laboratory testing, land survey, and slope stability analyses of the dams impounding the ash ponds at the Labadie Power Station. The investigation, testing and analyses was done in general accordance with our proposal dated January 29, 2010, and Ameren Missouri's request for proposal dated December 9, 2009. The purpose of this project is to evaluate the stability of the ash pond dams and conduct the necessary land surveys, subsurface explorations, and laboratory testing to define the critical section at each location. The slope stability analysis conducted was for the load cases required by the Missouri Department of Natural Resources (MDNR). The results of the slope stability analysis were compared to the required safety factors for the type and assumed hazard classification of each dam.

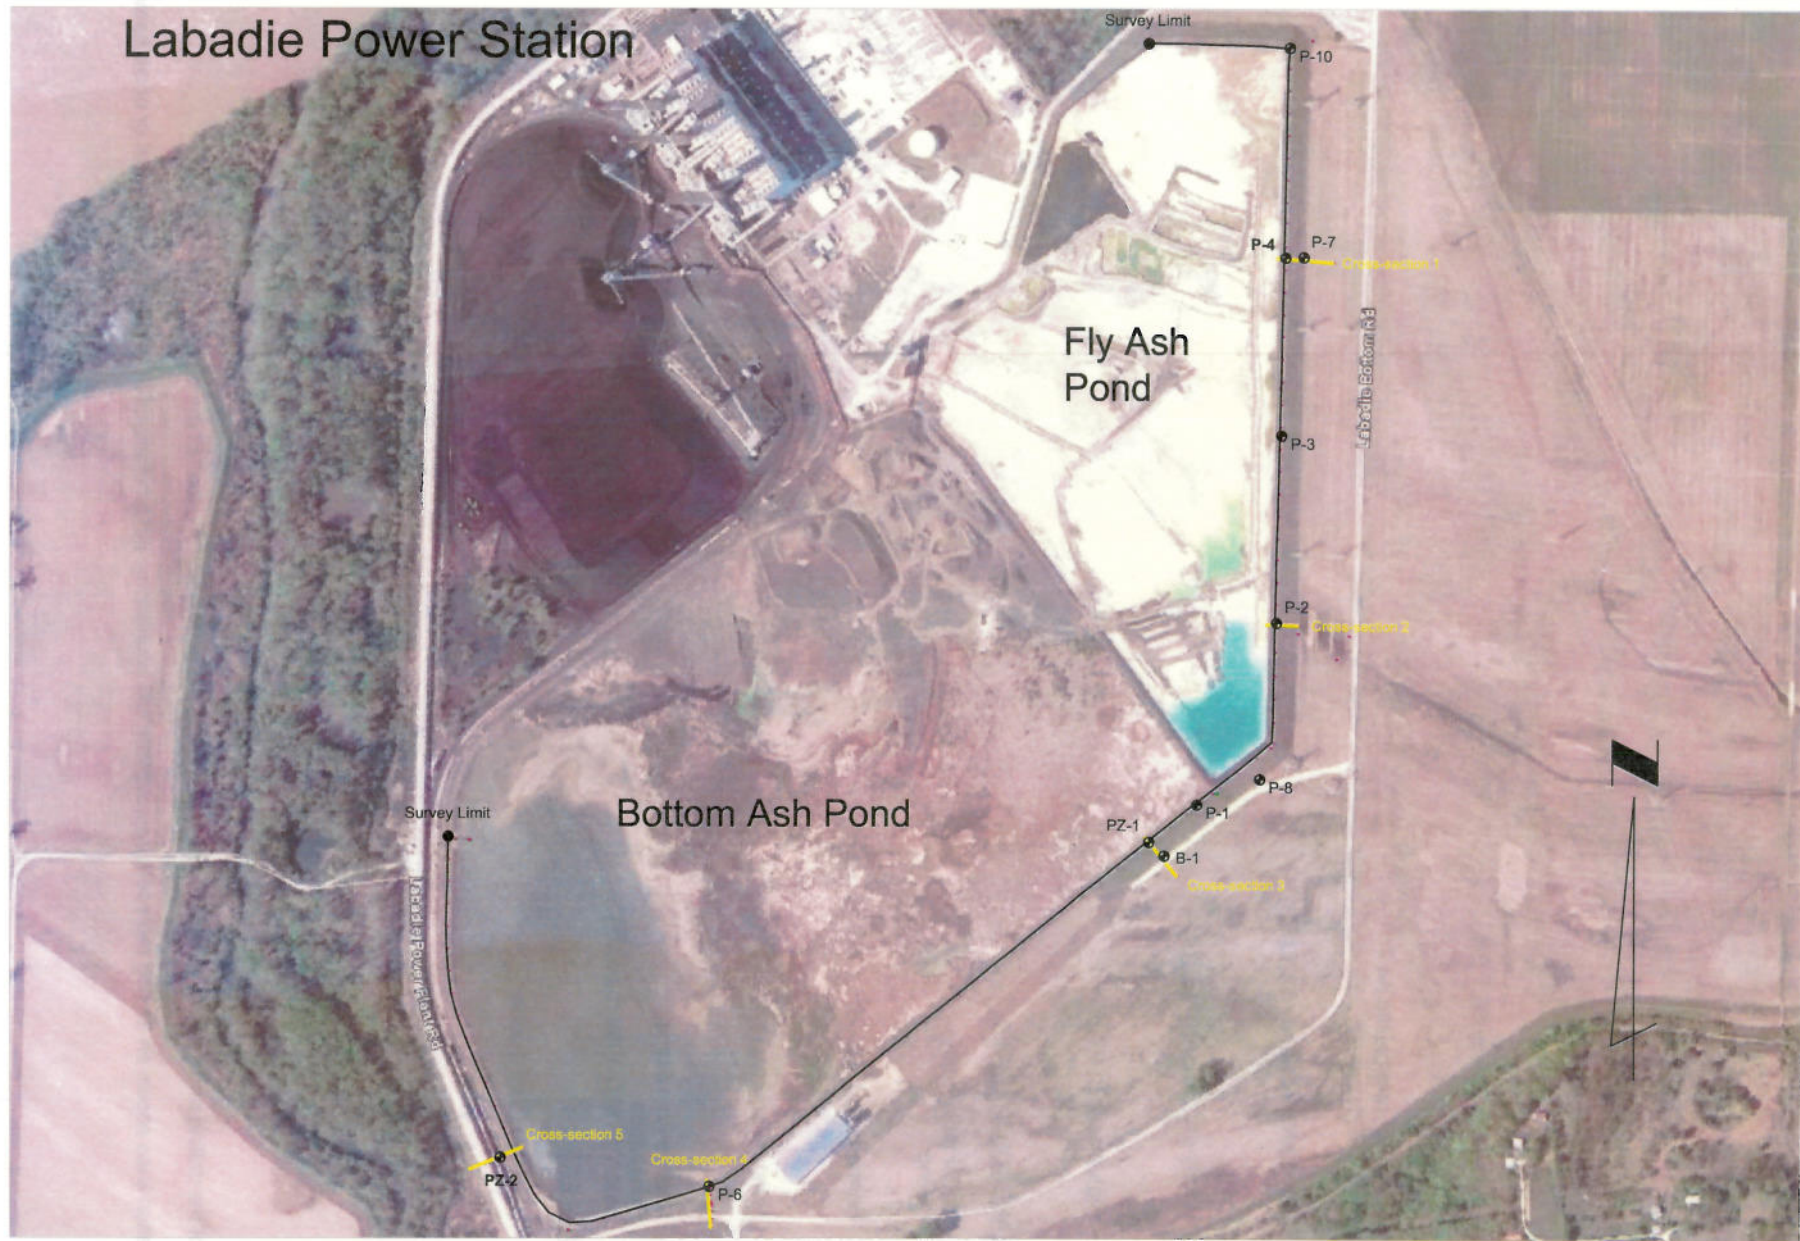
Elevation Profile Survey Limits
Locations of Cross-section and Borings

Geotechnical field investigations were conducted using rotary drilling and cone penetrometer test (CPT) soundings. The quantity of borings and soundings, and the approximate locations at the power station are shown in Figure 1. The boring locations were selected by RJ based on previous experience at these locations, to fill in gaps where there was no subsurface data, slope geometry and to provide soil profiles representative of as much of the embankment as possible. The elevations of the ground surface at the boring locations were measured by Zahner and Associates, Inc. The borings were made by Terra Drill, Inc. of Dupon, Illinois, as a subcontractor to Reitz & Jens. The borings were advanced through the soil using 4.25-in. I.D. hollow-stem augers. Mud rotary drilling was necessary in all 3 of the auger drilling locations. Holes were backfilled with cement grout, which was tremied from the bottom to the top.

The top of the fly ash pond dam was surveyed along the extents shown in Figure 1. The elevation ranged from 492.7 to 494.0-feet. A plot of the elevation profile along the crest of the dam is also shown in Appendix B. Two cross-sections were also surveyed, and showed upstream and downstream slopes

The top of the bottom ash pond dam was surveyed along the extents shown in Figure 1. The elevation ranged from 492.3 to 494.6-ft. A plot of the elevation profile along the crest of the dam is also shown in Appendix B. Three cross-sections were surveyed, and showed upstream slope of approximately 2 (H) to 1 (V) and downstream slopes of approximately 3 (H) to 1 (V). The approximate crown width is 20 feet. Drawings showing the slope geometry are presented in Appendix A.

CPT soundings were conducted at 2 locations at the top of the embankment. Only one of the soundings was advanced deeper than 9 feet due to the stiffness of the bottom and fly ash fill which make up this portion of the embankment. Two rotary borings were also drilled at the crest of the dam to a depth of 50 feet. One of the locations was on the west side of the pond and the other was on the south side of the pond. Temporary piezometers were installed in these locations. One additional rotary boring was drilled to a depth of 50 feet at the toe of the slope adjacent to the temporary piezometer on the south side of the pond. The locations of the CPT soundings and the rotary borings are shown in Figure 1.

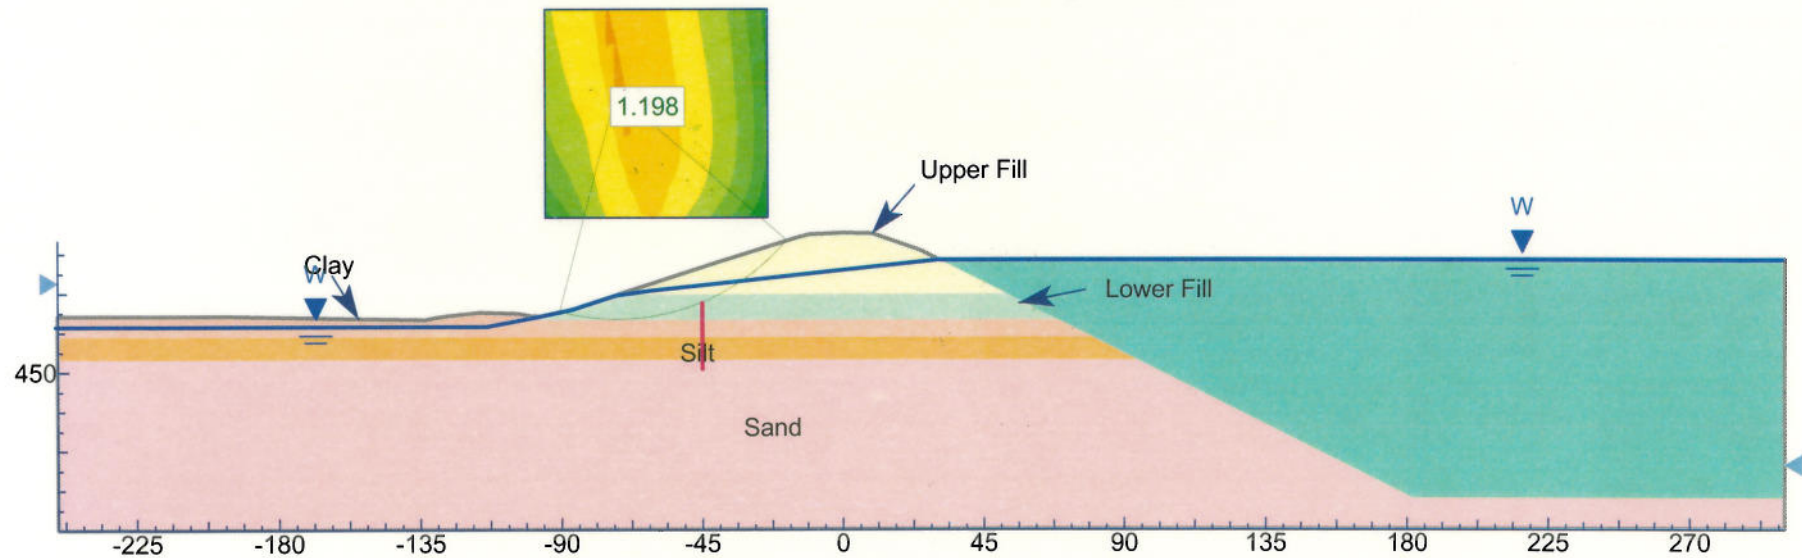
Labadie Power Station
Seismic, Full Reservoir
(Casagrande, 1937)
Cross-section 3

Material: Upper Fill
Unit Weight: 120 lb/ft³
Friction Angle: 32 degrees

Material: Clay
Unit Weight: 120 lb/ft³
Cohesion: 400 psf
Friction Angle: 19 degrees

Material: Bottom Ash
Strength Type: No strength
Unit Weight: 100 lb/ft³
